DATE OF INSPECTION: 3/6/2025

YEAR BUILT: 1906

Property Inspection Report

Portland, OR, 9999

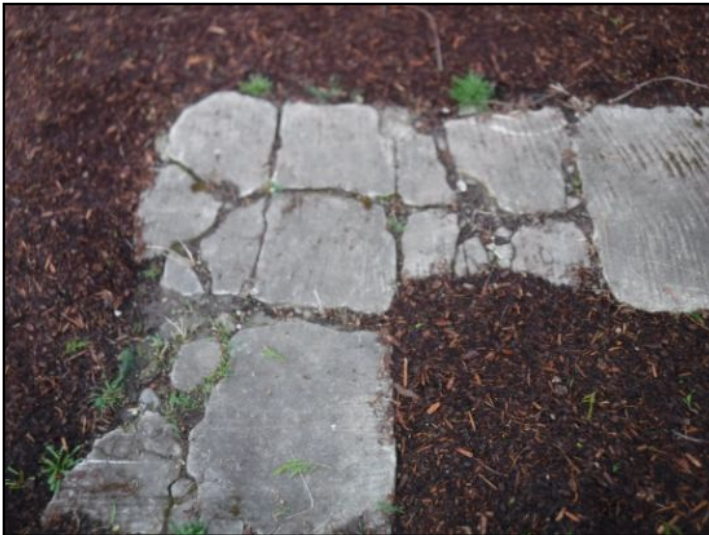
Walkway - Moderate to significant cracking / surface damage noted. Recommend consulting with concrete specialist to determine best course of action.

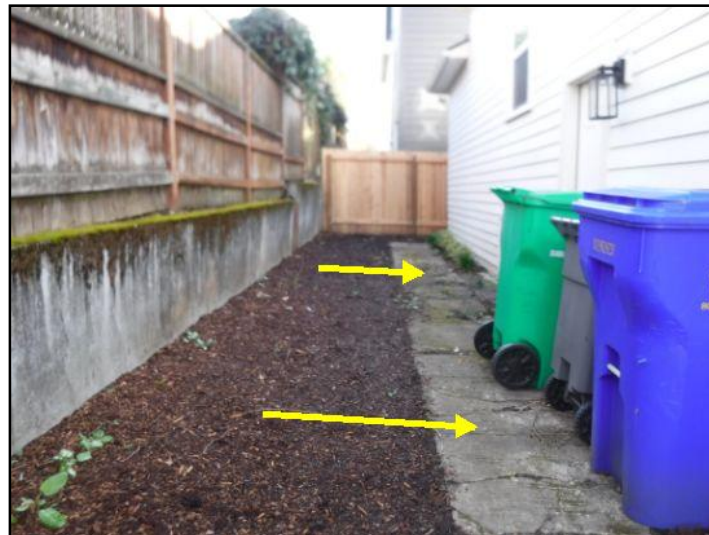
There are one or more areas that slope towards the building and tend to promoted water under the home. Recommend drainage corrections to prevent adverse issues associated with water draining into the soil adjacent to the home / structure.

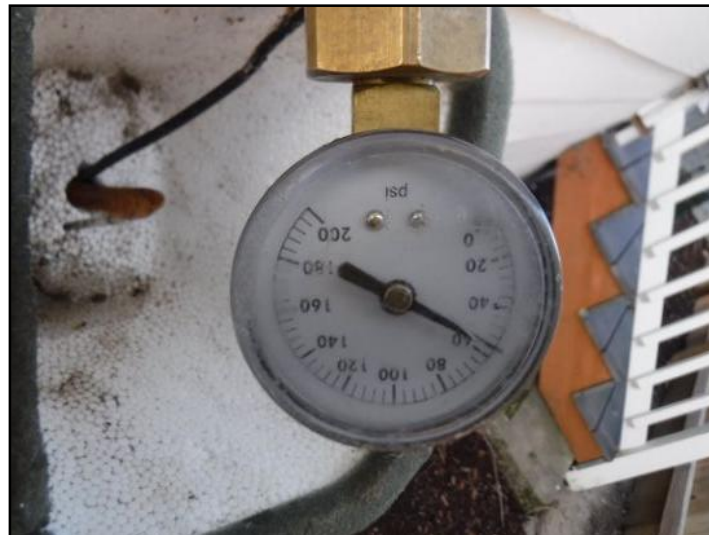
55 psi was the approximate pressure noted at exterior faucet

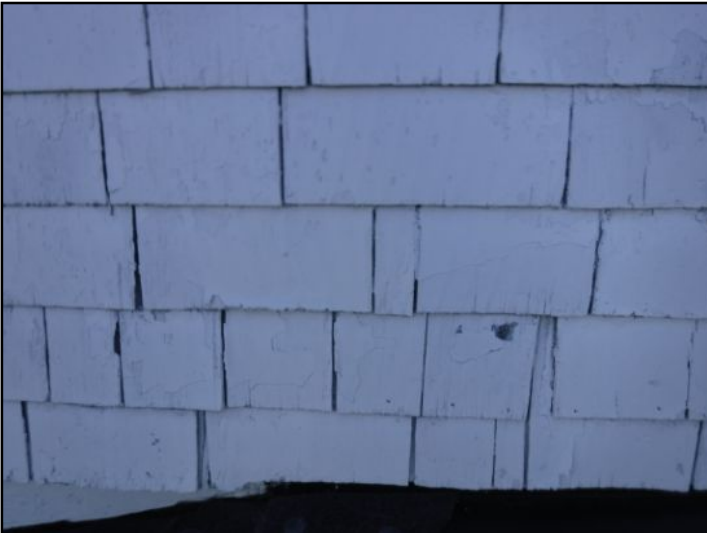
Older siding is intact, but shows some signs of aging. Monitor for wear. Repair cracks, gaps or holes as needed. Treat surfaces with stain or paint as needed to protect against siding damage and structure against the elements.

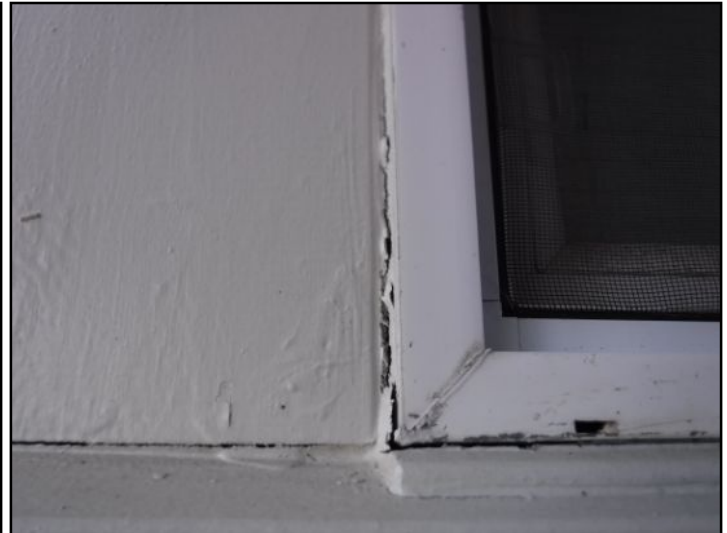
Caulking missing or damaged. Recommend correction by qualified professional to protect underlying materials from damage.

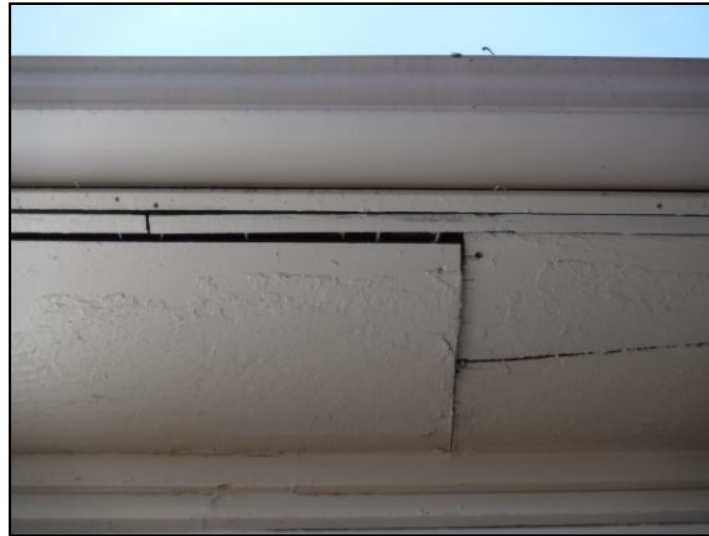
Exposed portion of rafters / eaves / soffit / sheathing has some holes, cracks, gaps, openings or damage. Repair or replace as needed by qualified professional to prevent water intrusion into structure.

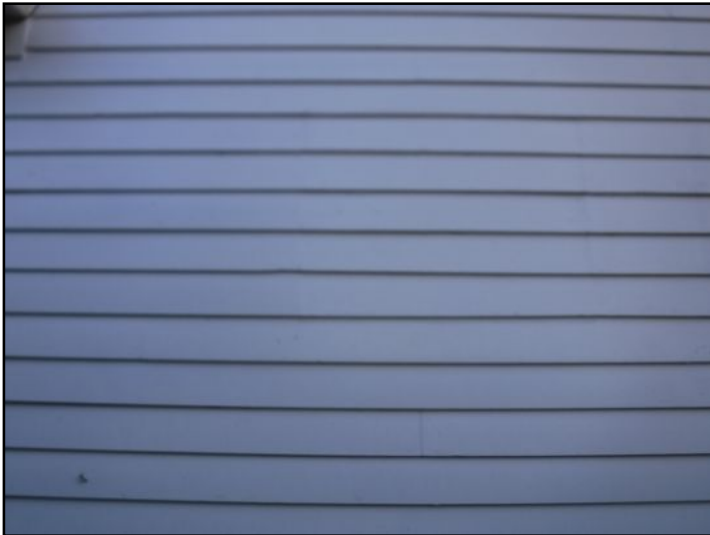
Home was constructed 1978 or earlier when lead paint was permitted. Lead was a significant component in paint and it is possible that some of the paint used inside the home or on the exterior contains lead. It cannot be stated that the paint used contains lead without proper testing. Lead is associated with health hazards. It is important to not permit this type of paint to peel or otherwise become detached from the intended material. Harm occurs as a result of ingestion or inhalation of the material. Recommend containing the material through encapsulation which can be accomplished by painting-over or sealing in some other fashion. Abatement is the removal of the material and is often expensive and best left to specialty professionals to accomplish.

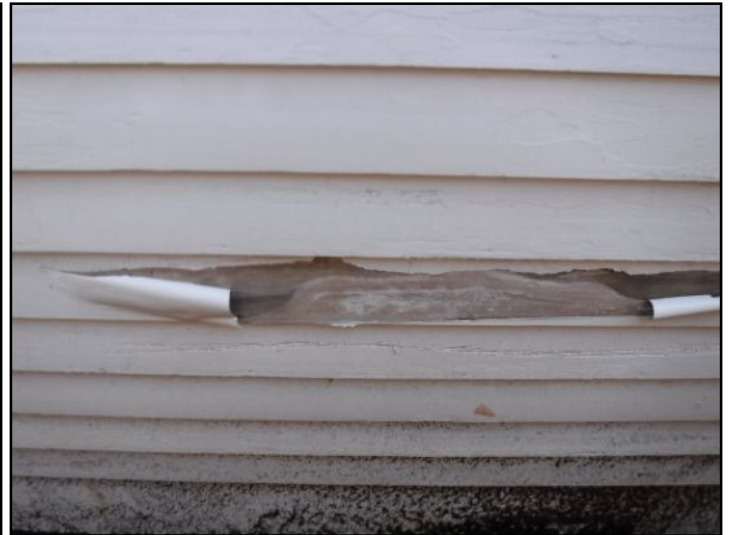
Peeling or chipping paint noted in some areas. Recommend use of qualified professional to remove loose material and prepare surfaces and re-paint to preserve the siding and protect the home from the elements.

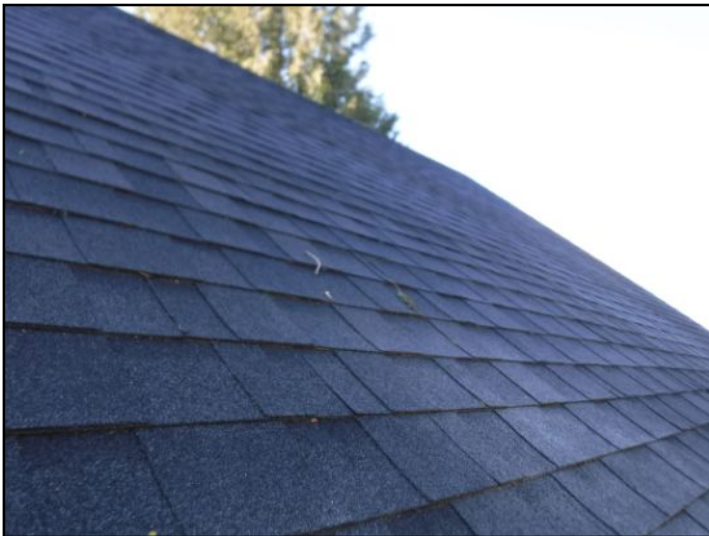
The asphalt shingles appeared to be in good condition with minimal wear

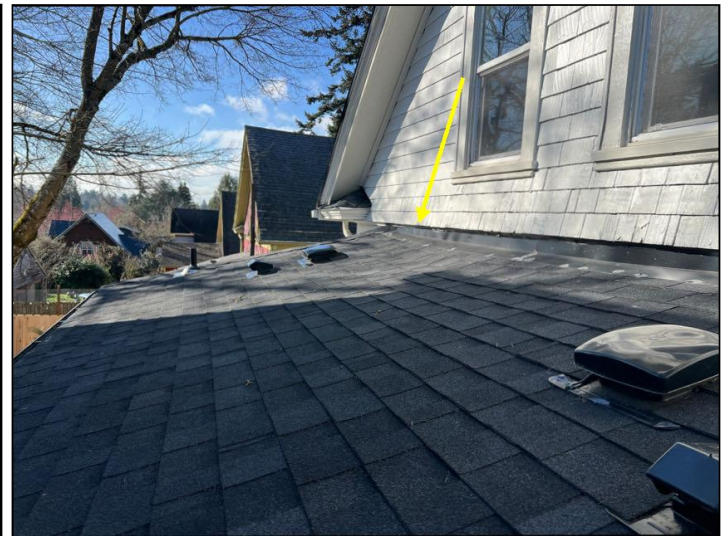
Lower level roof at rear of home: Areas of rooftop are sagging or bowing. Recommend evaluation and repairs as needed by qualified contractor.

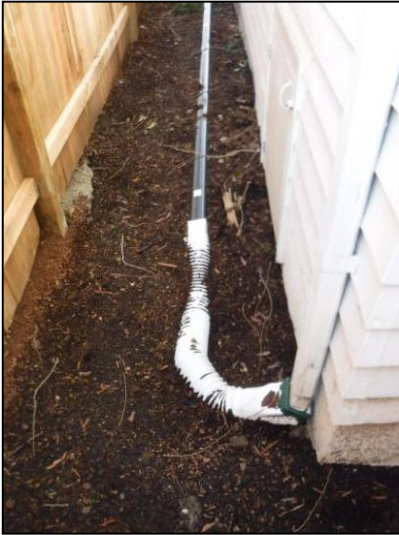
Downspout material has been used as drainage piping to carry water away from the home. This material is not intended for this application and it will likely leak a moderate to significant amount. Consider replacing with actual drainage piping to better remove water away from the home.

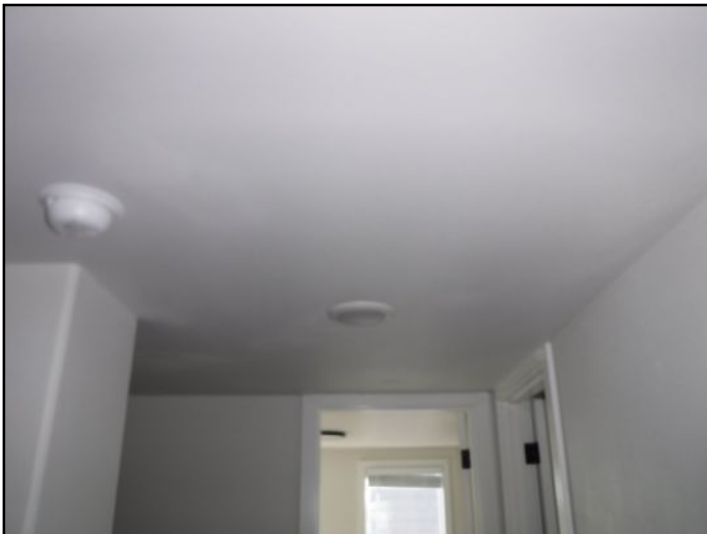
Small enclosed area above the ceiling on the upper level has no access point. Recommend installation of access point and evaluation with corrections as needed by a qualified professional.

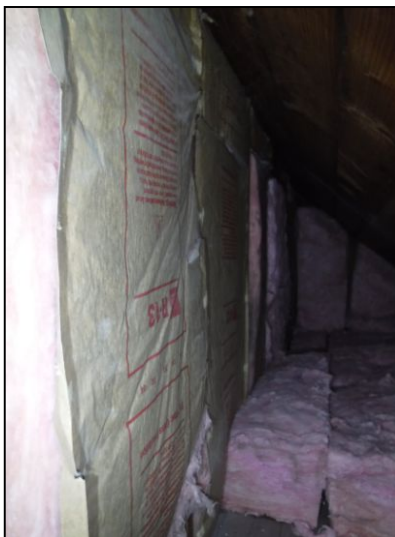
Attic area access from upper level bedroom closet: Paper covered insulation present and this portion of the insulation is facing towards the attic area. Moisture in this area may result in mold, damage, decay or bio-growth on the paper surfaces. Monitor, modify and correct as needed to prevent adverse conditions.

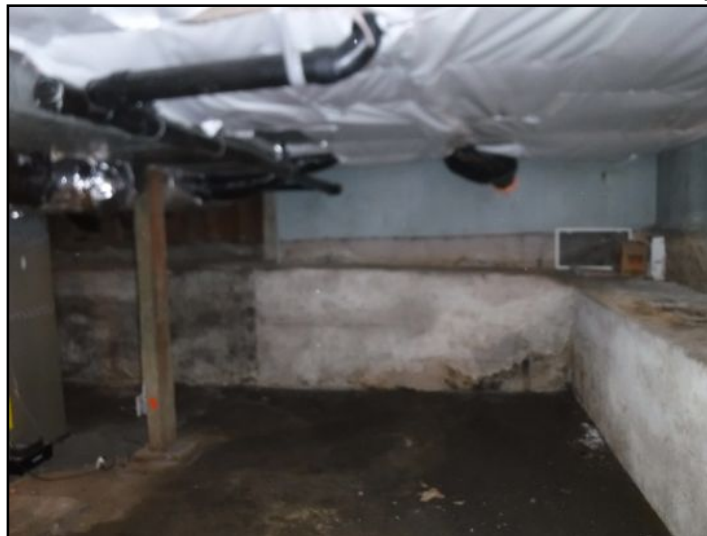
Basement foundation with slab floor and concrete perimeter walls

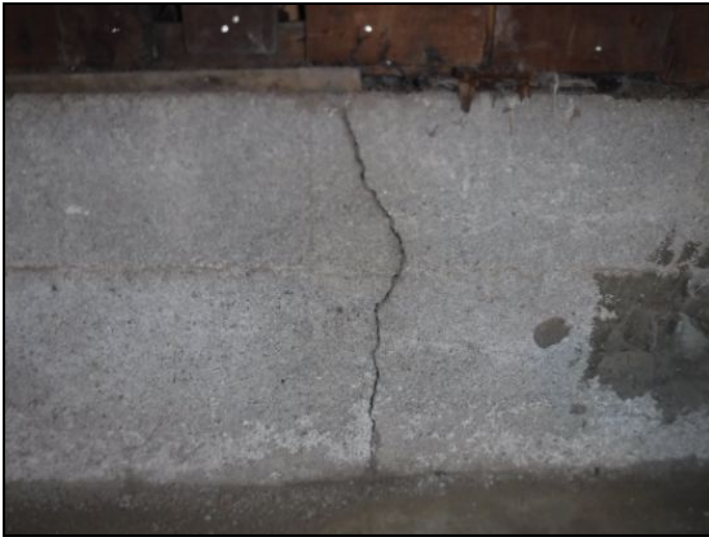
Cracks (1/4" or less) present in: foundation walls. Consider sealing them to prevent water infiltration. Generally speaking, cracks that are less than 1/4" are not commonly regarded as being structurally significant. Seal and monitor.

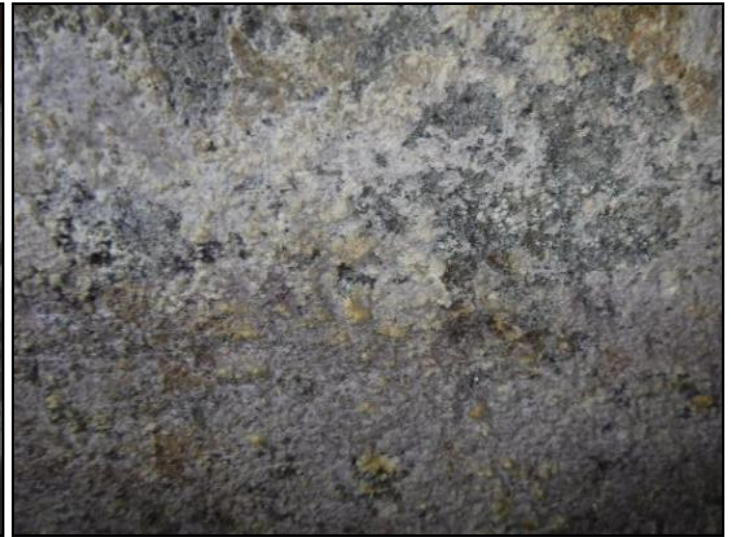
Efflorescence observed; this is a mineral deposit left behind from previous exterior water infiltration. Consult with drainage experts for best applications of drainage systems for outside the foundation perimeter and within the perimeter.

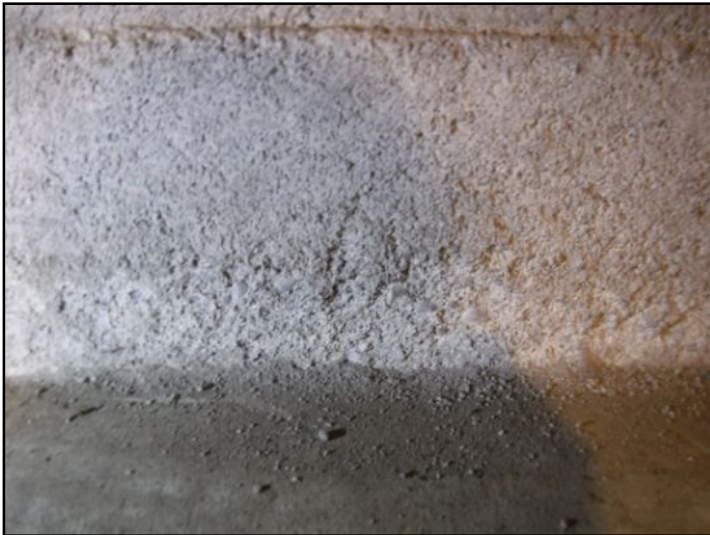
Spalling / deterioration noted on concrete foundation walls. It is recommended to have a foundation specialist evaluate the foundation walls and provide services to prevent further spalling / deterioration.

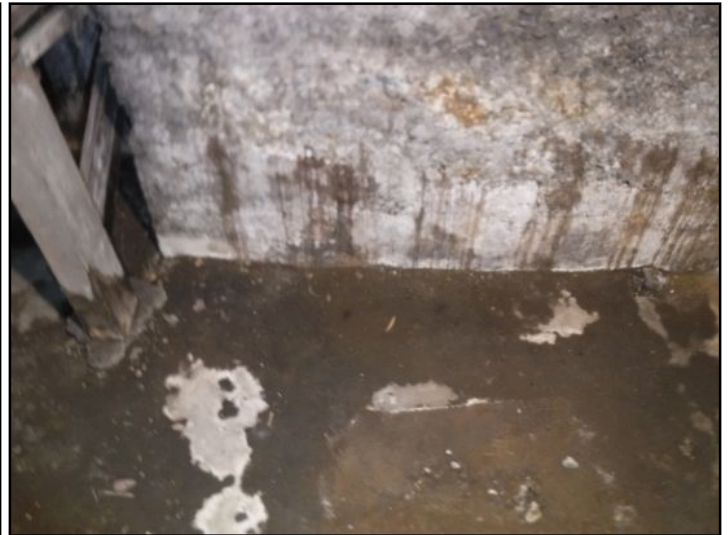
Moisture intrusion was observed numerous areas of the foundation. Moisture can create high humidity, mold & can damage stored items & finishing materials. Recommend a wet basement specialist review the foundation for correcting the water intrusion and advise as needed.

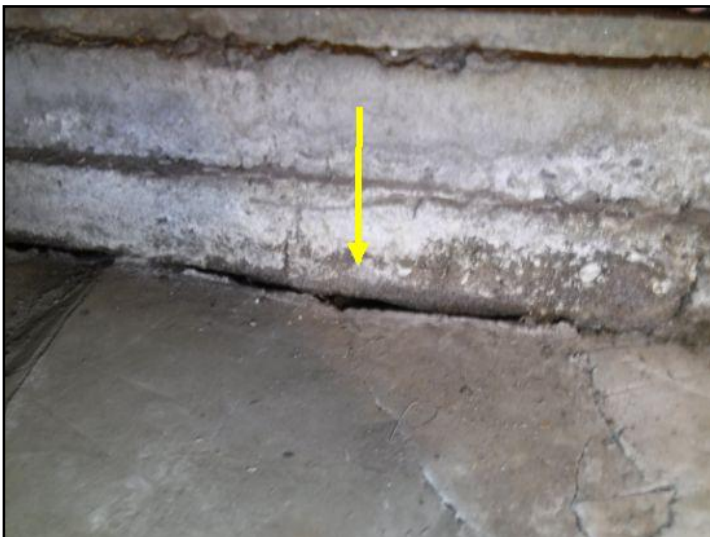
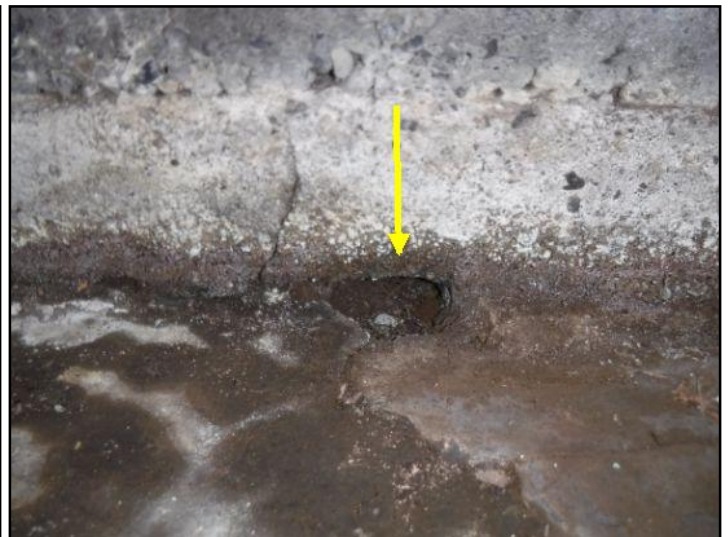
Gaps / eroded areas noted below foundation walls in some locations. It is recommended to have a qualified professional back fill these areas and seal the openings to prevent further erosion.

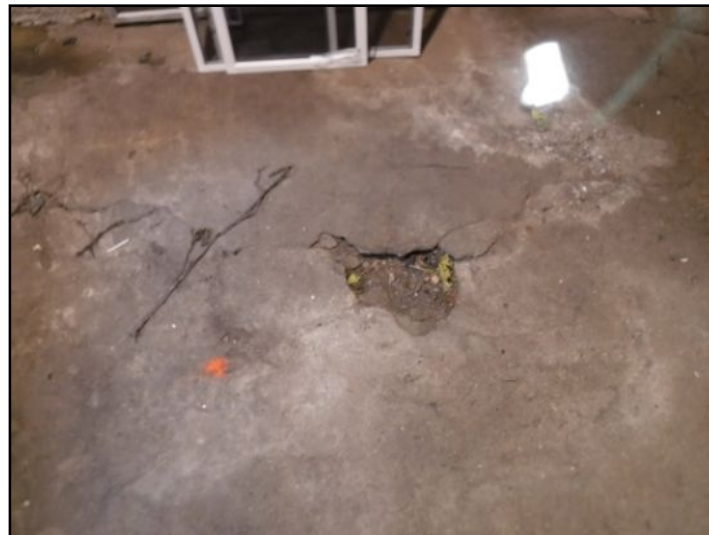
Cracks / surface damage noted. Consult with Concrete specialist to determine best course of action and associated costs.

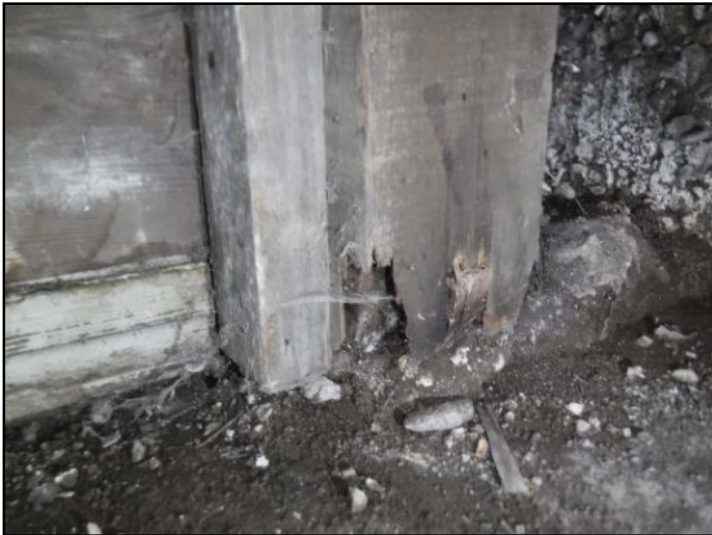
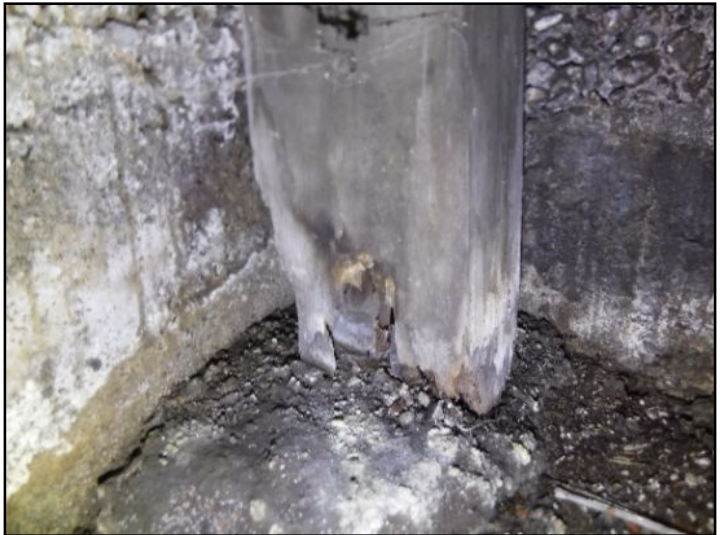
Water damage / decay noted at the base of several posts below basement stairs. Corrections by a licensed contractor is recommended.

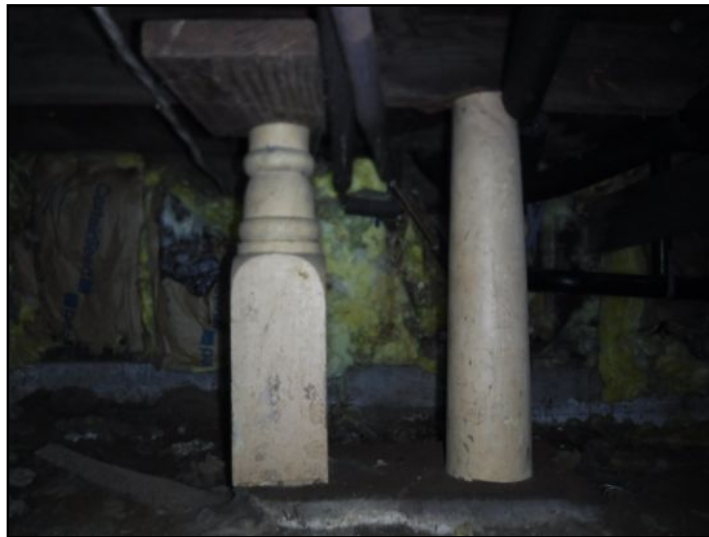
Interim support structures noted which are support devices which have been added to the foundation area to provide additional support in a specific area where it was needed.

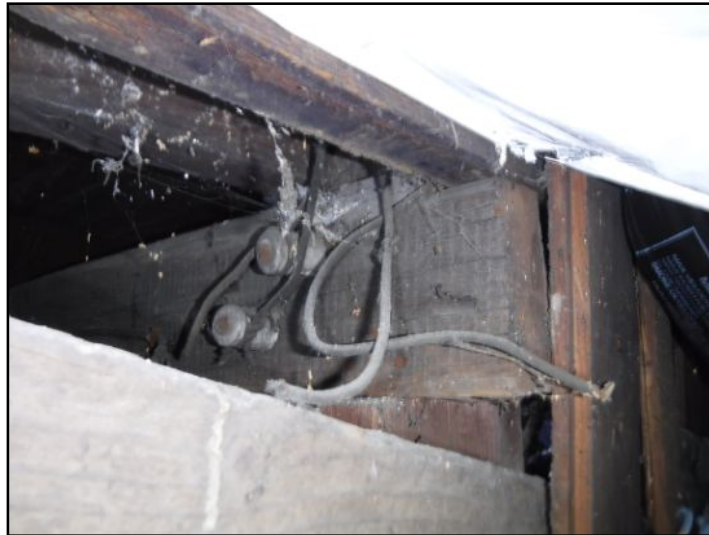
Knob and Tube wiring observed appears to be non-functioning. Have electrician review and remove if possible or if desired.

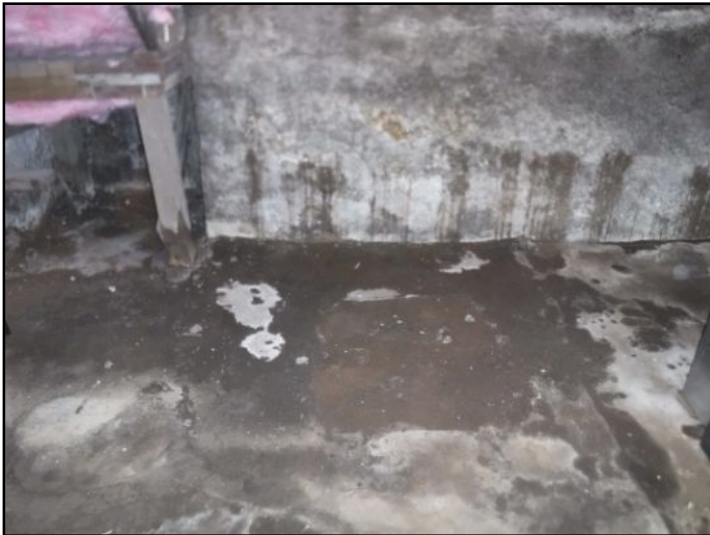
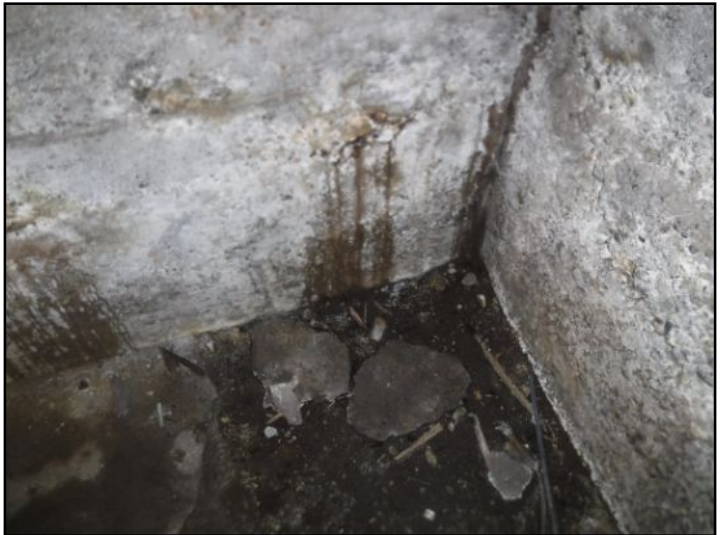
Evidence of past water noted. Water marks at various points within this area. It appears to be from poorly directed surface water / rain water. Recommend having qualified professional provide evaluation and corrections to exterior grading / drainage along with any needed corrections inside the foundation area to eliminate water in this area.

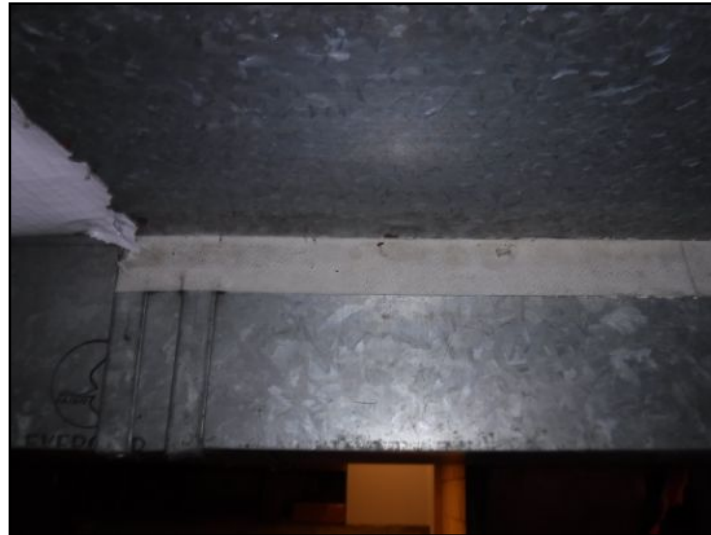
Heat ducts are wrapped with materials consistent with that containing asbestos which is a know cancer causing material. If in good condition and left undisturbed this material causes no need for alarm. Proper handling and abatement by Qualified contractors is recommended if repairs or upgrades are performed. Consider, also, the idea of encapsulating the asbestos tape with heat-tape or other materials.

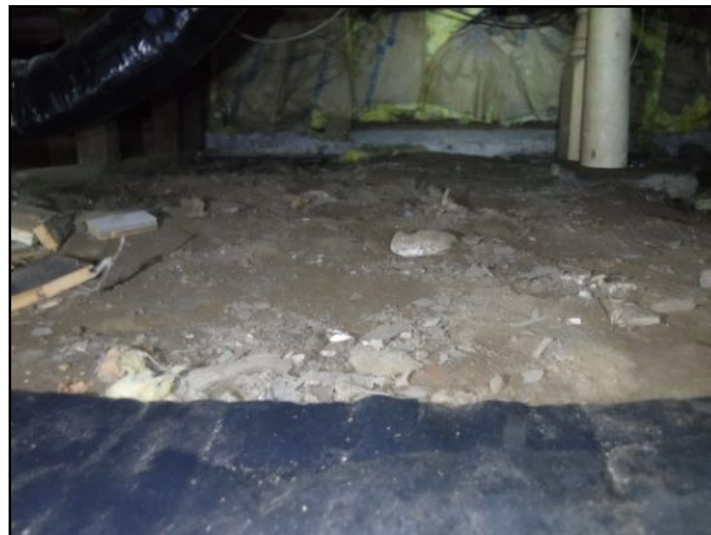
Vapor barrier needs to cover entire ground. Redistribute existing cover and / or add more material if needed for full coverage.

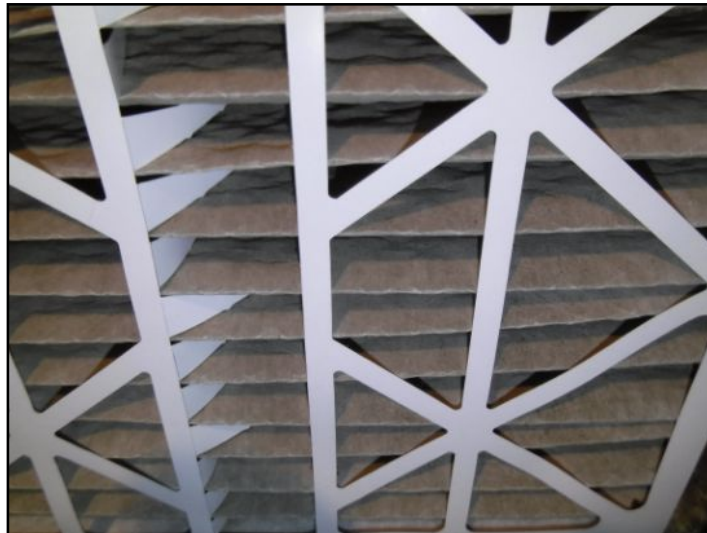
Furnace filter dirty. Needs replacement.

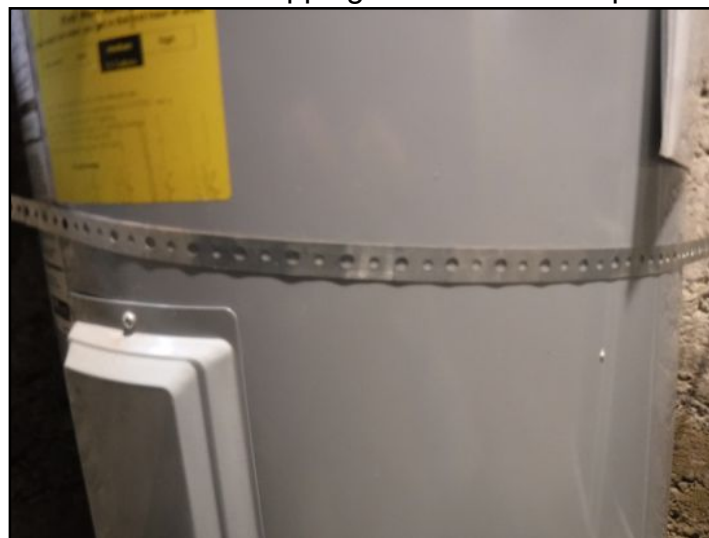
The water heater is strapped with plumbers tape. Recommend upgrading to Hot Water Heater strapping which is more capable of handling movement.

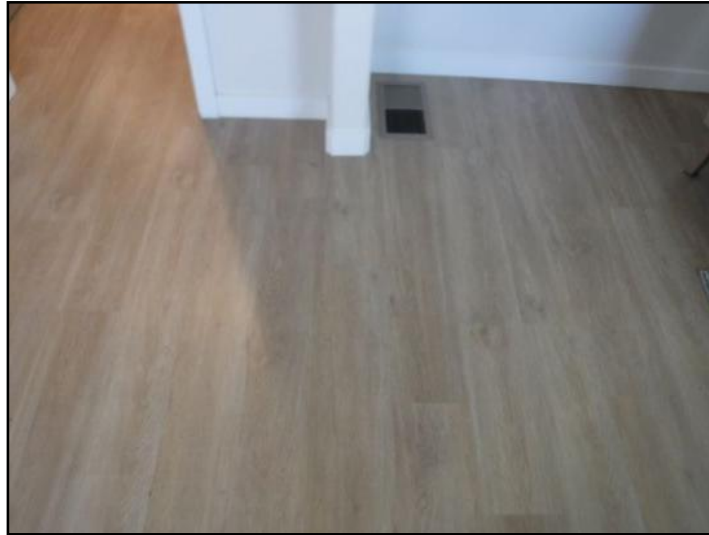
Irregularities were noted below the flooring in the living room area. This is common in older homes and the issue did not appear to be excessive. If concerned, have a licensed contractor evaluate this area to determine the cause and severity of the issue. Have a licensed contractor make corrections as needed or if desired.

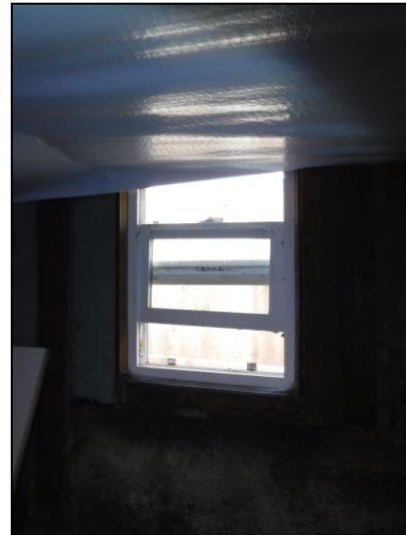
Single hung window in living room: Cracked glass noted. Recommend corrections to improve safety, security, access to light.

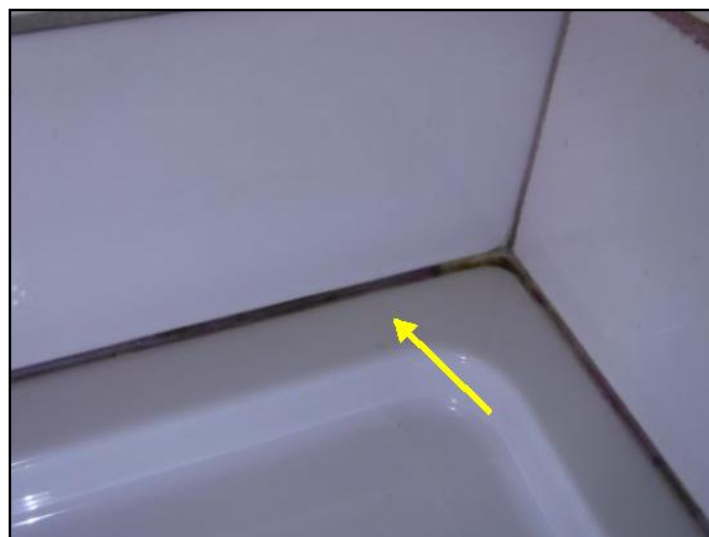
Discolored grout / caulking may be an indication of a bio-growth. Recommend correcting as needed to prevent spread to the adjacent materials. Recommend examining adjacent material, if possible, for current damage / bio-growth and correcting as needed.

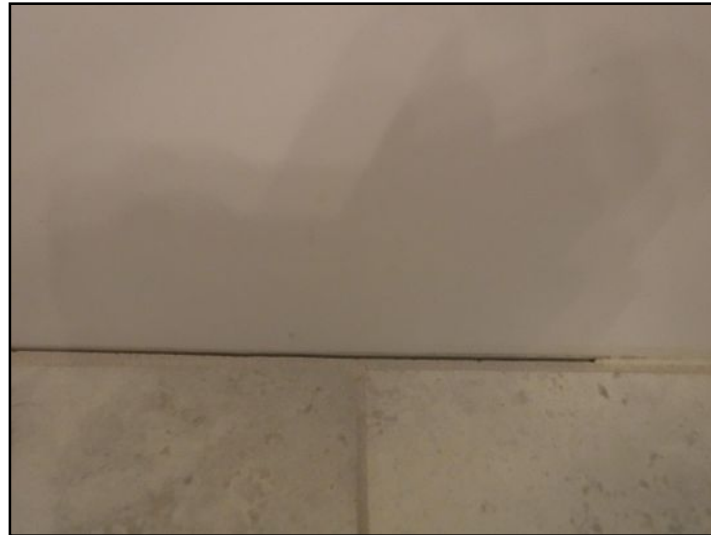
Caulking is missing, damaged, in need of replacing or inconsistently applied at edge of plumbing fixture(s). Recommend fresh caulking bead to prevent water damage to underlying materials

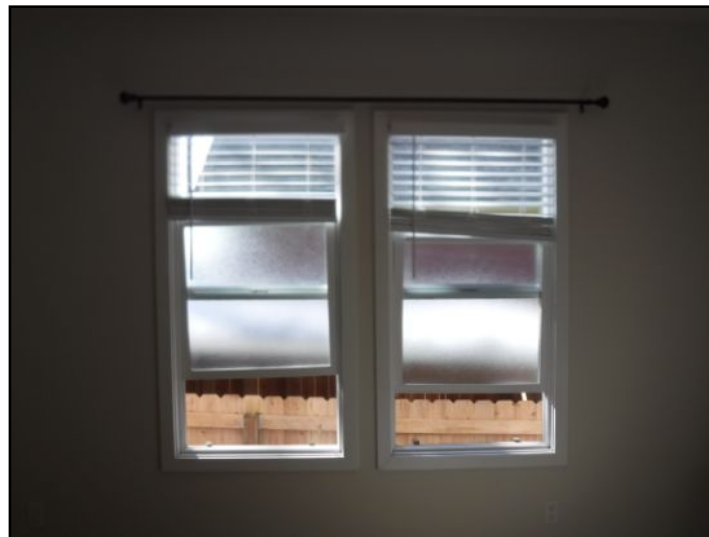
Both Windows: Counterbalance system is damaged, missing, operates poorly or not operative. Recommend corrections to restore function.
